Mini Case Study: Hydro-Electric Dam

Project: Measure head cover for turbine
Location: Chief Joseph Dam – Bridgeport, WA

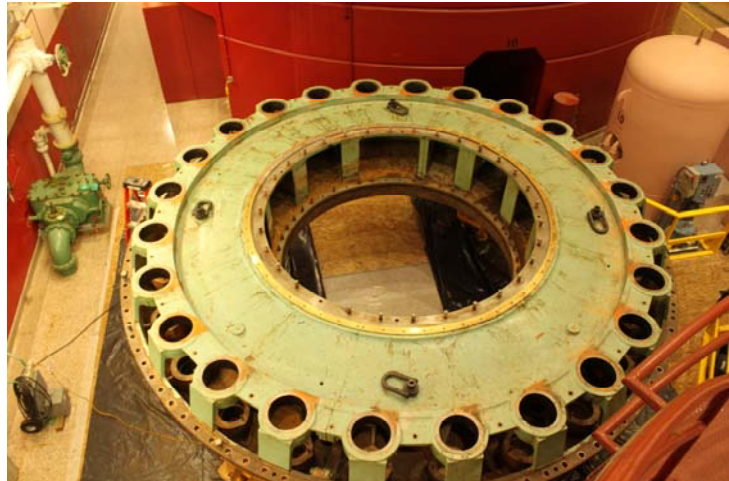
Rotor Assembly Head Cover

Alstom Hydro required measurement of the rotor-assembly head cover. The head cover had been removed and was supported on cribbing. The head cover was over 20ft diameter with 24 hole-positions. There were internal and external bores of varying sizes that required measurement at various angles and on multiple planes. Careful planning was required to determine the best positions for the laser tracker.

The project ultimately required taking laser tracker measurements from five positions to cover the entire scope of work: the top, the bottom, and three different side positions. With the use of multiple control points (monuments) located around the periphery of the head cover, we were able to move the laser tracker as necessary and measure over 365 points and features. The entire inspection was completed in 2 days.

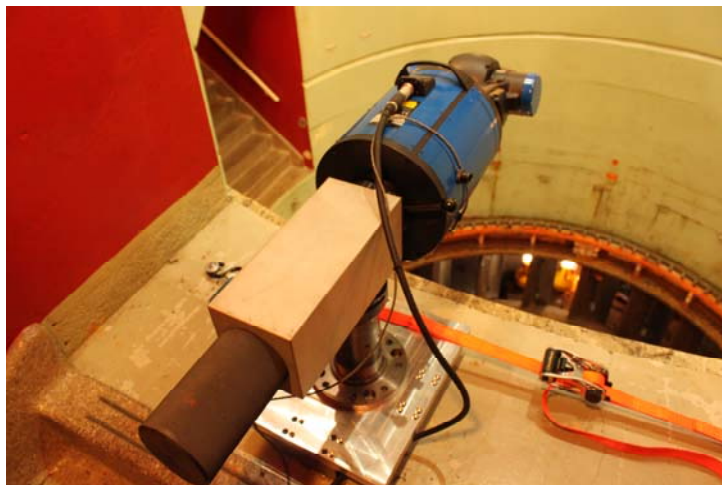
Faro laser tracker mounted horizontally

The Faro laser tracker was also used to measure the bottom ring located inside the stator / shaft area. The laser tracker was mounted above the bottom ring horizontally to maximize the measuring envelope. The Faro horizontal attachment was used to provide a counterbalance for the laser tracker allowing it to hang safely out in space. The computer was located at the bottom ring and all the readings were taken using the Faro laser tracker wireless network feature.

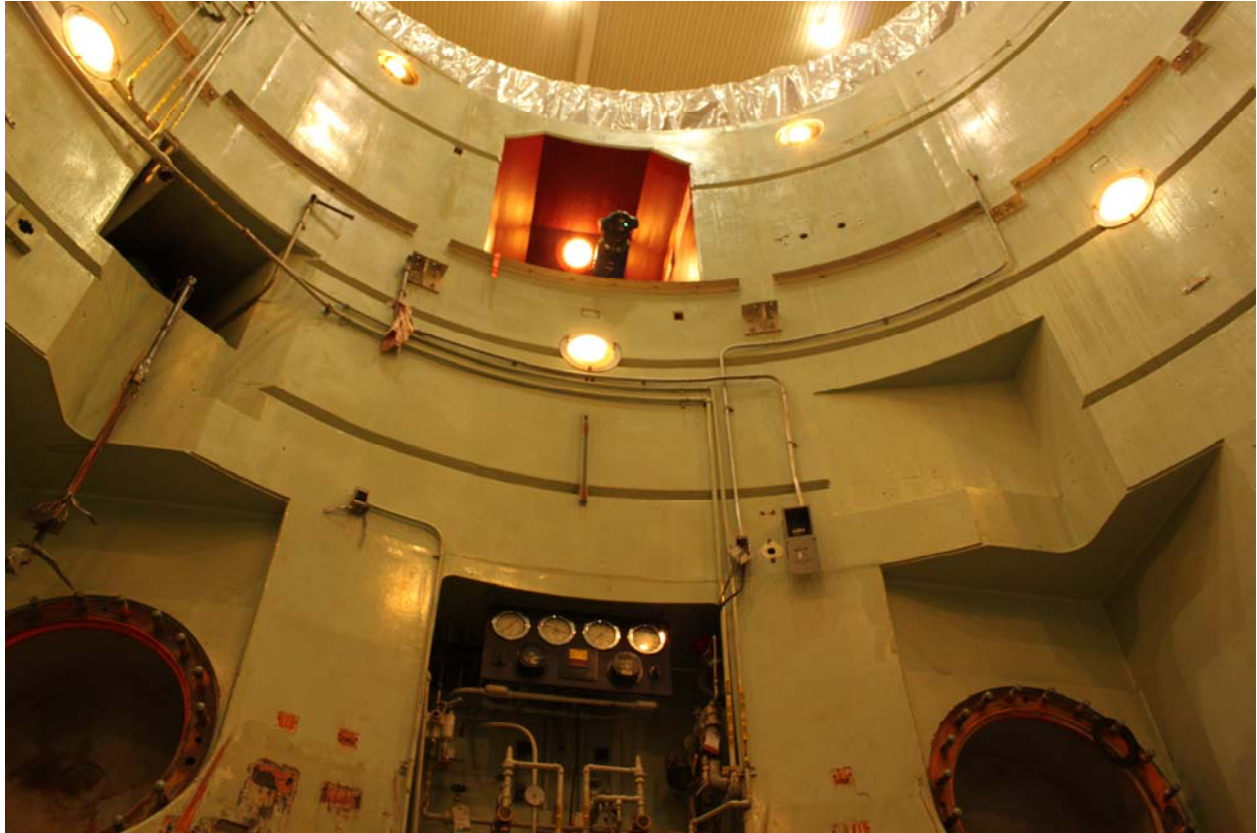
Faro laser tracker viewed from the bottom ring
