Mini Case Study: Paper Mill – Roll Repair

Project: Measure a 1 million hole-pattern on paper mill roll

Location: Metso Paper – Federal Way, Washington

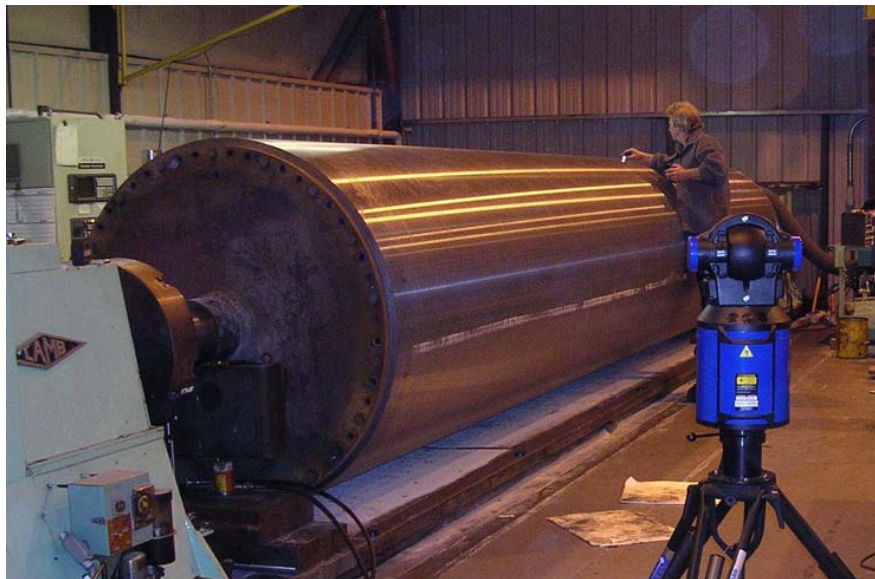
Checking hole drilling positions on a paper mill roll with a Faro Laser Tracker

Metso Paper called us in to check a very large paper mill roll with about 1 Million holes that were to be re-drilled on a CNC multi-drill machine. The roll had a precision hole-pattern around the surface of the outer diameter. Information was needed to ascertain whether the hole-pattern was correct before moving to the next phase of the project. A nest was customized to fit the diameters of the holes and measurements were taken at different distances and angular rotations. The data was analyzed and adjustments were made so the drilling operation could proceed. This procedure was performed in 1 shift.
