Mini Case Study: Gear Manufacturing

Project: Large Gearbox Inspection

Location: The Gear Works - Seattle, Washington

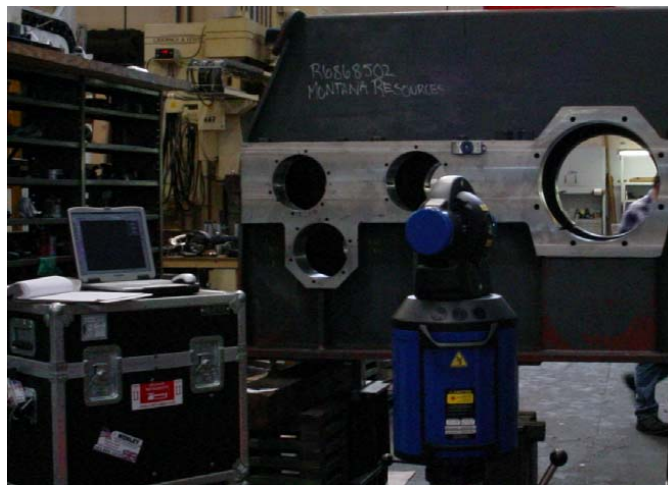
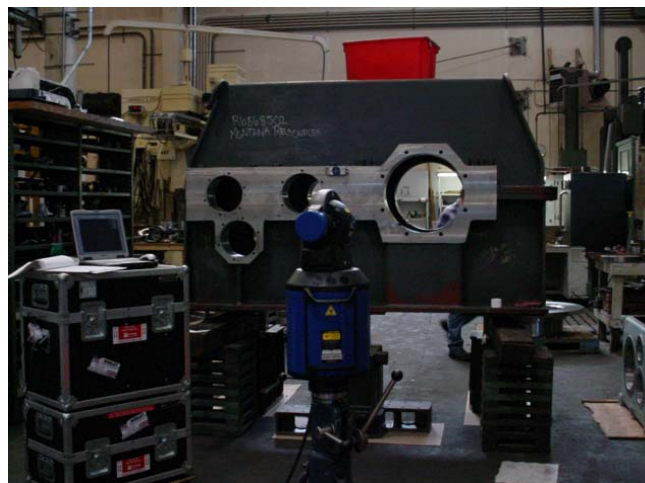
The Faro Laser Tracker was used to measure the positions and alignment of the gearbox bores. Normally this very large gearbox would be put on the CNC Horizontal Boring Machine and would be measured. This takes time and waiting for a customer decision can tie up the machine causing production schedule problems. The laser tracker was able to “map out” the bore positions in a few hours and free up the machine for production.

Laser Tracker Measuring Gearbox Bores
