## **Mini Case Study: Why check a new machine?**

**Project: 3-Axis Machining Center with Rotary Attachments**

**Location: Oregon**

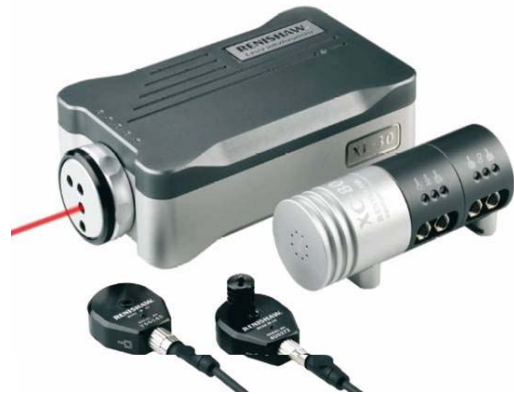
Renishaw XL-80 Laser Interferometer

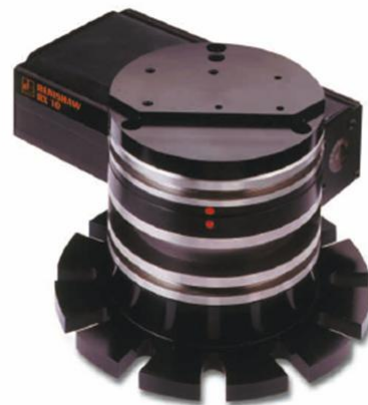
After checking and compensating the X, Y and Z Axis with the Renishaw XL-80 Laser Interferometer, a problem was found when we checked the attached Rotary A and B Axis with the Renishaw RX10 rotary axis kit attachment. We found over 600 arc seconds of error in the Rotary axis on both machines. How could this be? The rotary department at the machine manufacturer explained, "...there is no way that they could have that much error..." and that they are always "bench tested twice" prior to being shipped to the customer.

Renishaw RX10 Rotary Axis Kit

It turns out that the controls on the machines had been upgraded and that they had not been tested with the interface to the rotary table. Morley had uncovered a problem that if not fixed prior to releasing the machine to production would have put valuable parts at risk and may have affected our customer's commitments to customers. The company was very grateful that they had called Morley to check their brand new machines.
